RF/RMRS-98-253.UN

FINAL CLOSE-OUT REPORT

BUILDING 123 DECOMMISSIONING PROJECT

Rocky Mountain Remediation Services, L.L.C.

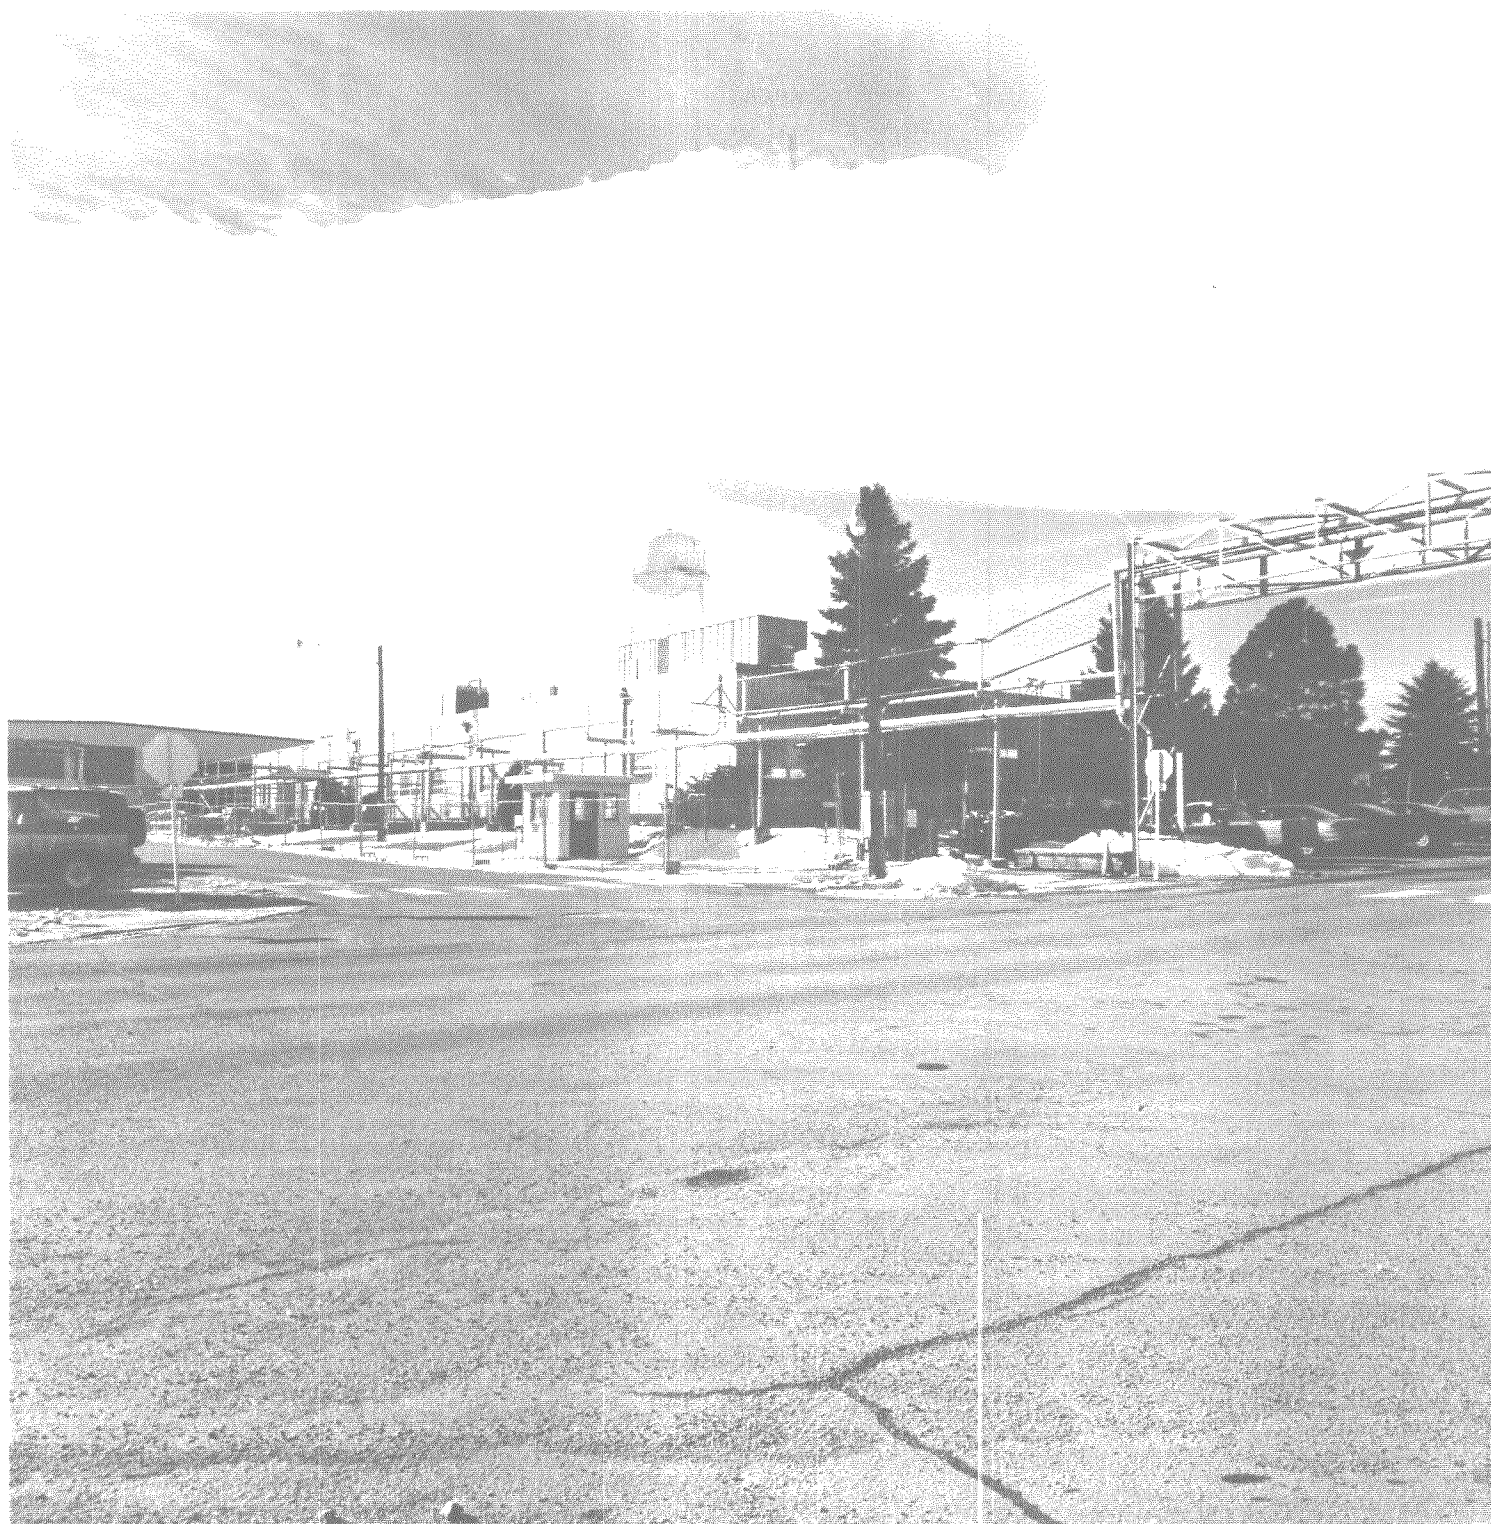
DESCRIPTION - ROCKY FLATS FIELD OFFICE
BLDG. - 123
CONTRACTOR - DENVER WEST REMEDIATION & CONSTRUCTION
#50276 - 01 - LOOKING SW FROM SW CORNER OF BLDG. 331
12/4/97

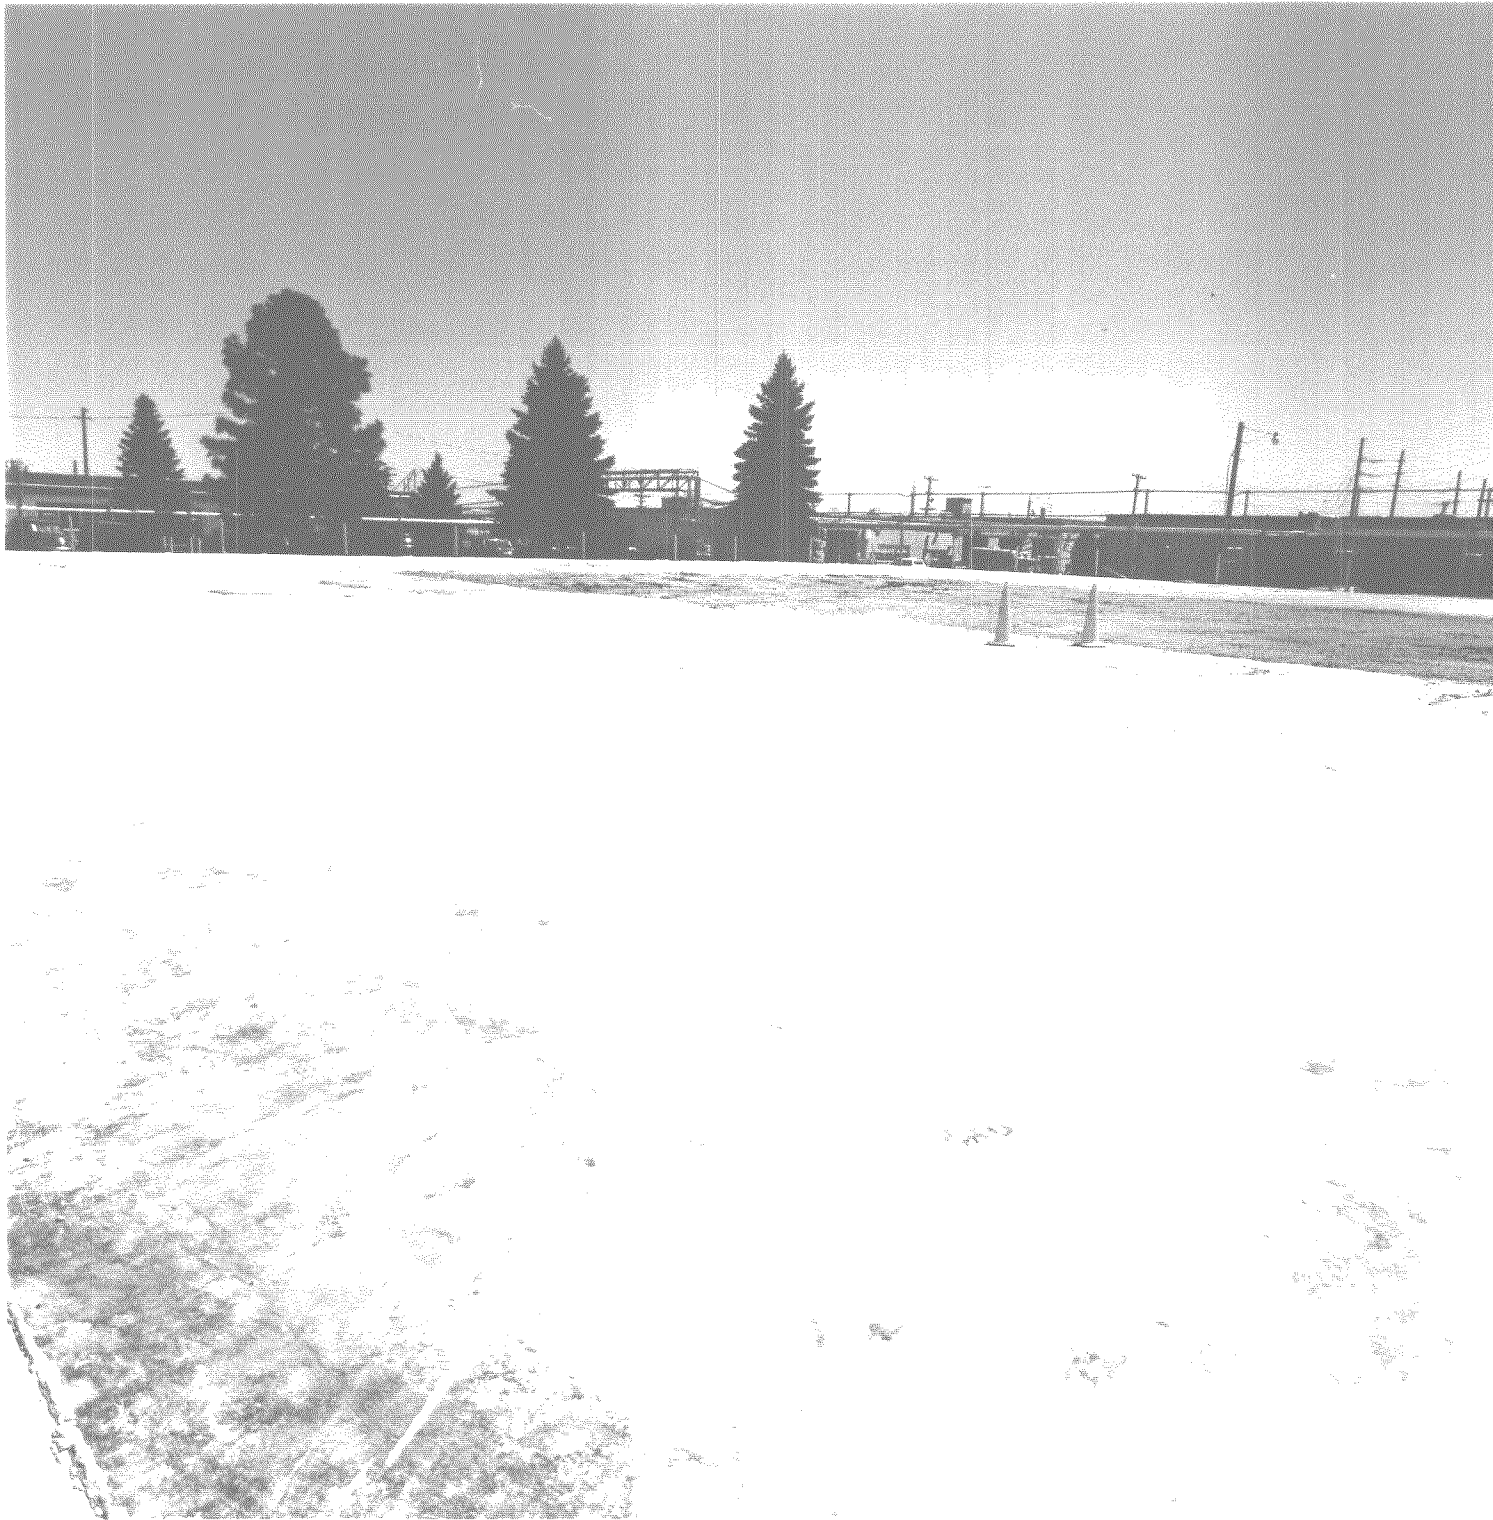
DESCRIPTION - ROCKY FLATS FIELD OFFICE
BUILDING 123
CONTRACTOR - DENVER WEST REMEDIATION AND CONSTRUCTION
#50643 - 06 - BUILDING 123 SLAB, LOOKING NORTHEAST AFTER DEMOLITION
5/27/98

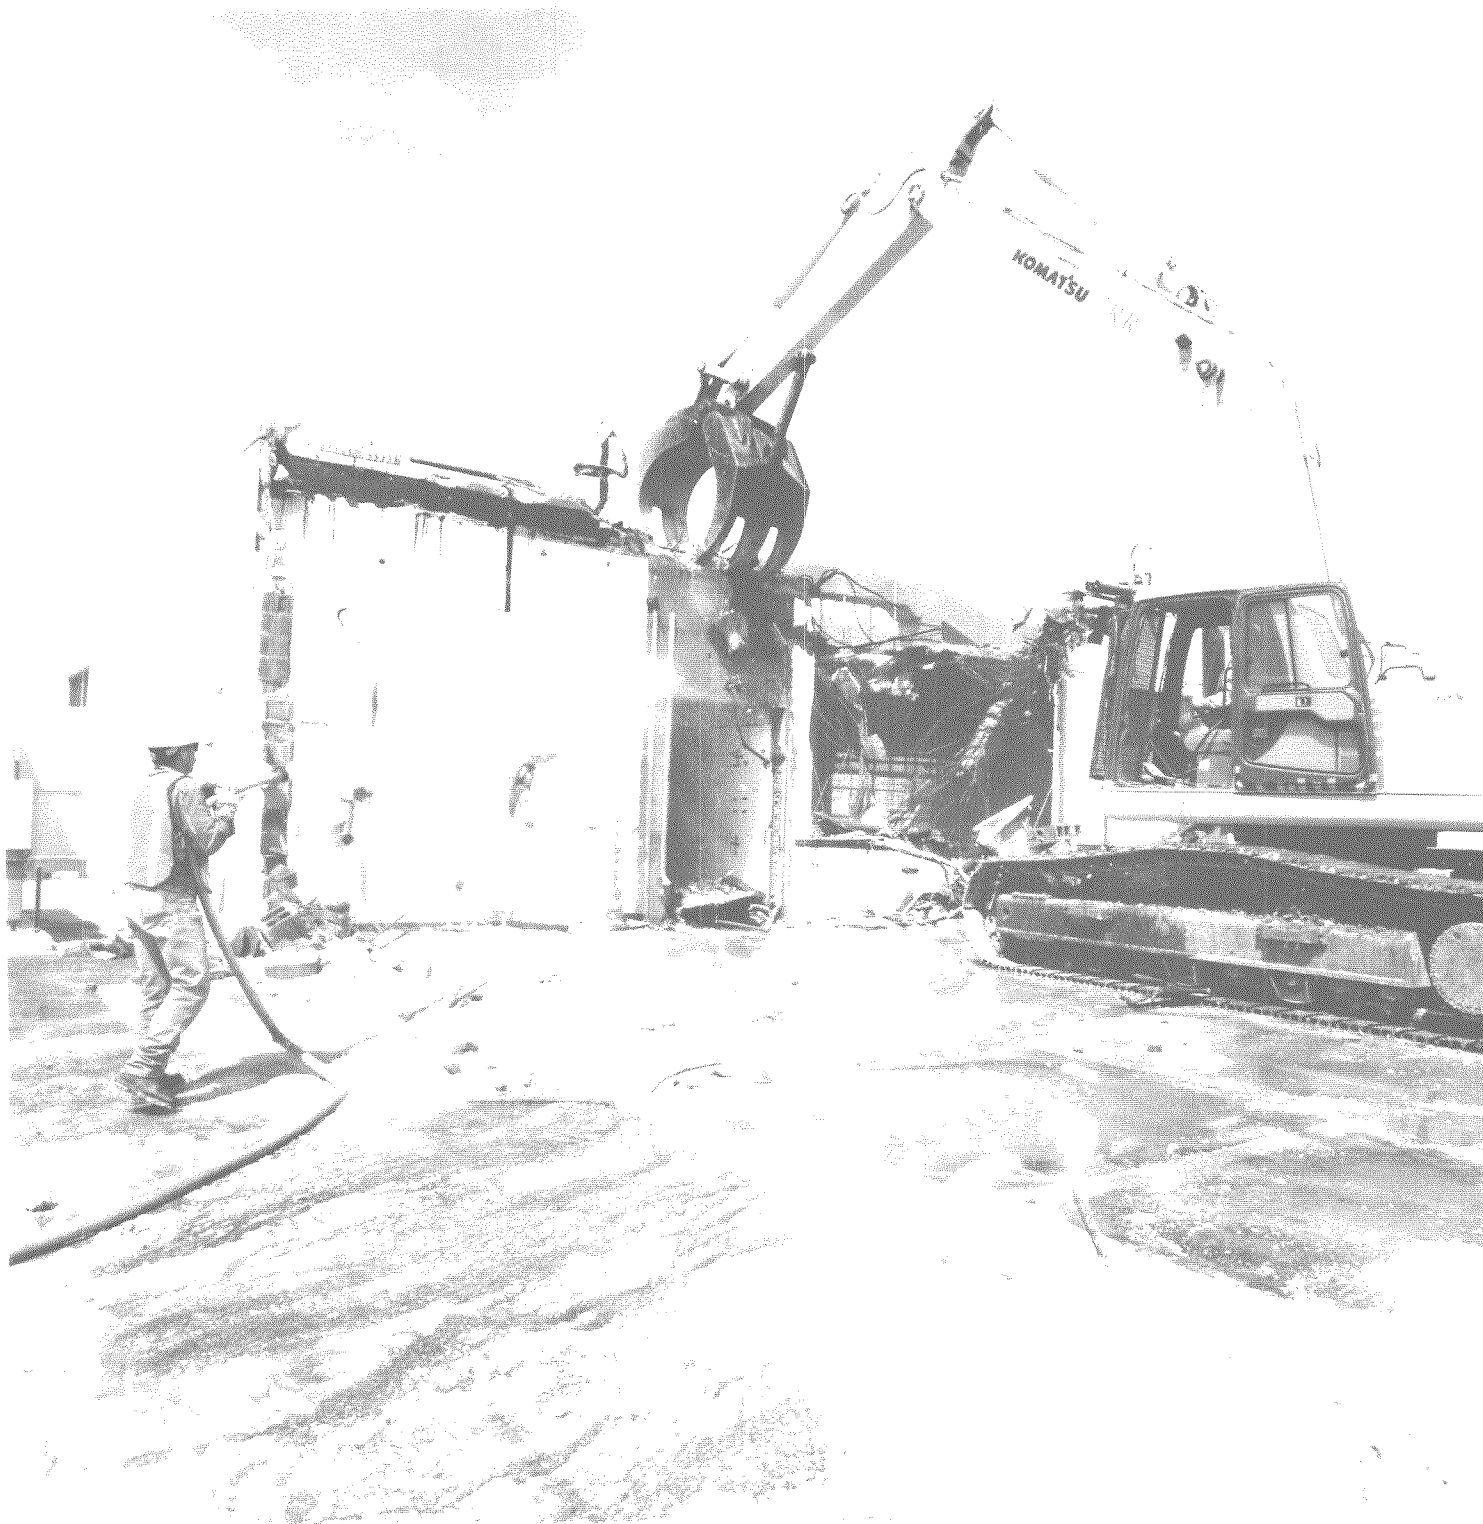
DESCRIPTION - ROCKY FLATS FIELD OFFICE
BUILDING 123
CONTRACTOR - DENVER WEST REMEDIATION AND CONSTRUCTION
#50623 - 20 - BUILDING 123, LOOKING NORTHEAST AT DEMOLITION ACTIVITIES
5/14/98

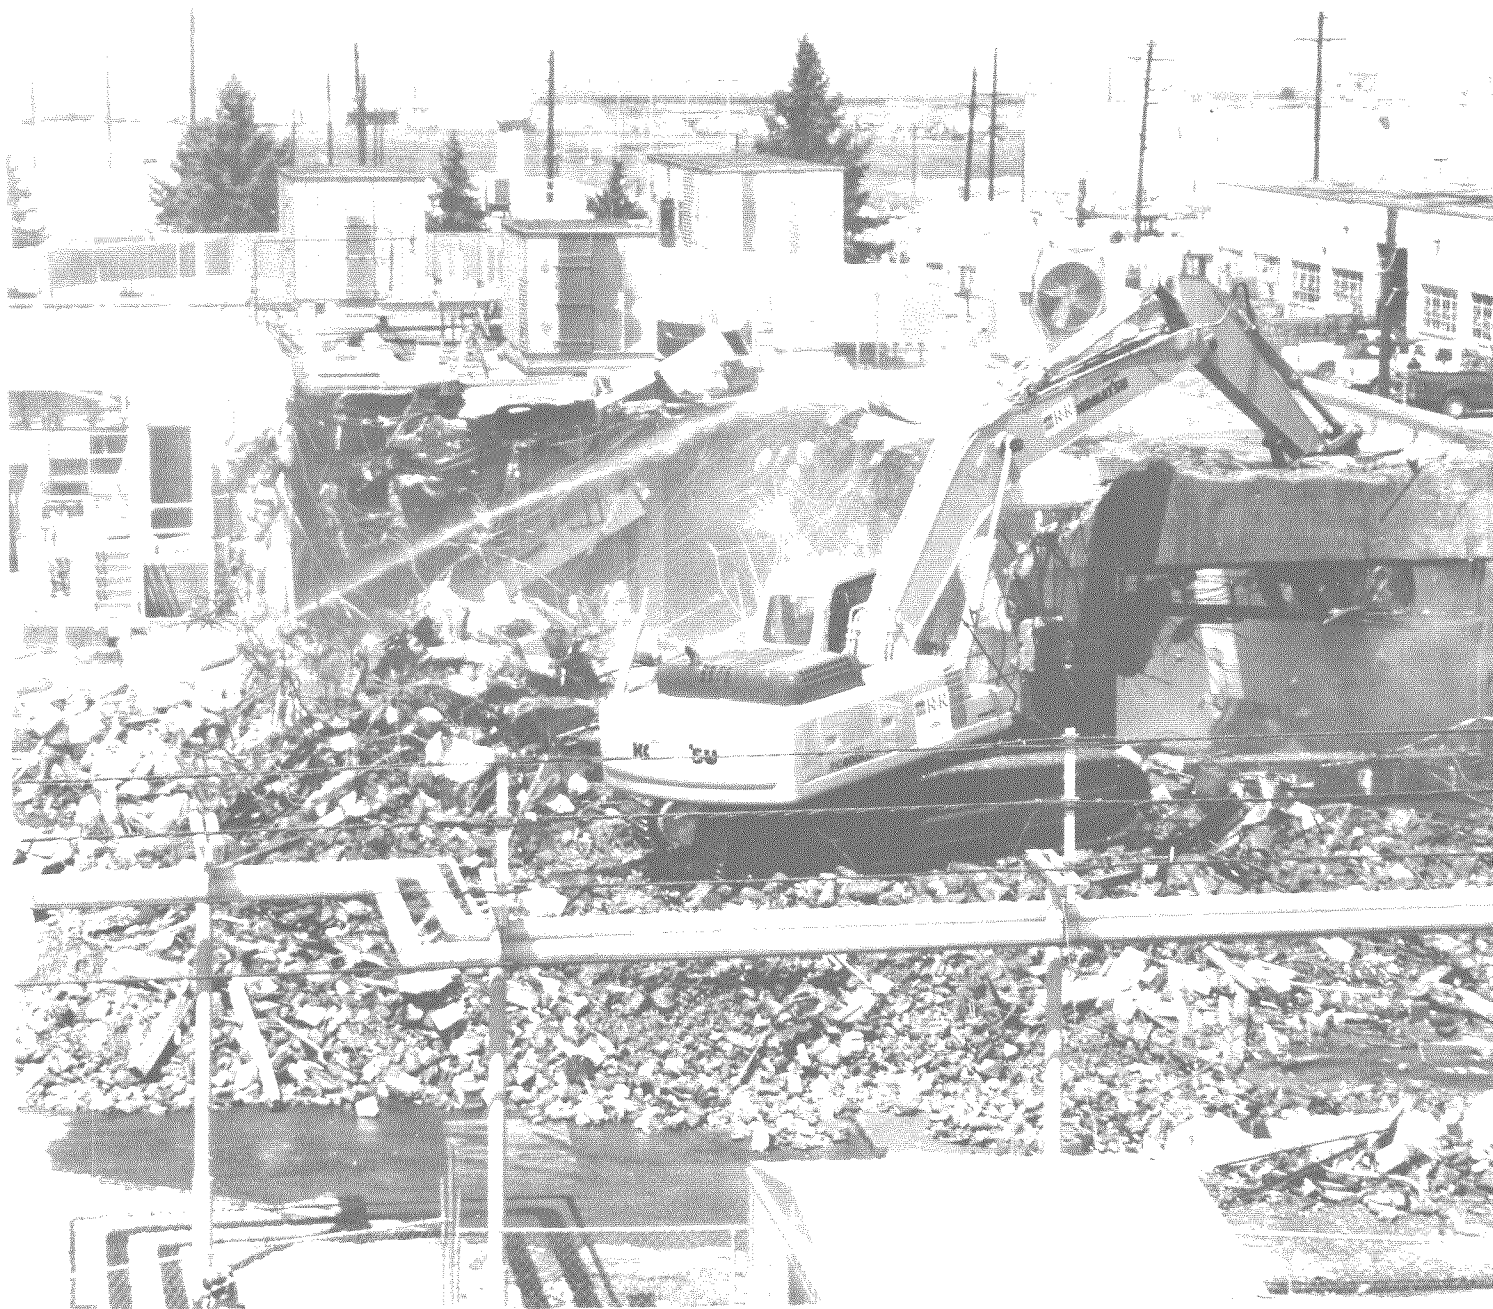
#50584 - 18 - BUILDING 123 DEMOLITION, LOOKING NORTH FROM THE ROOF OF BUILDING 460

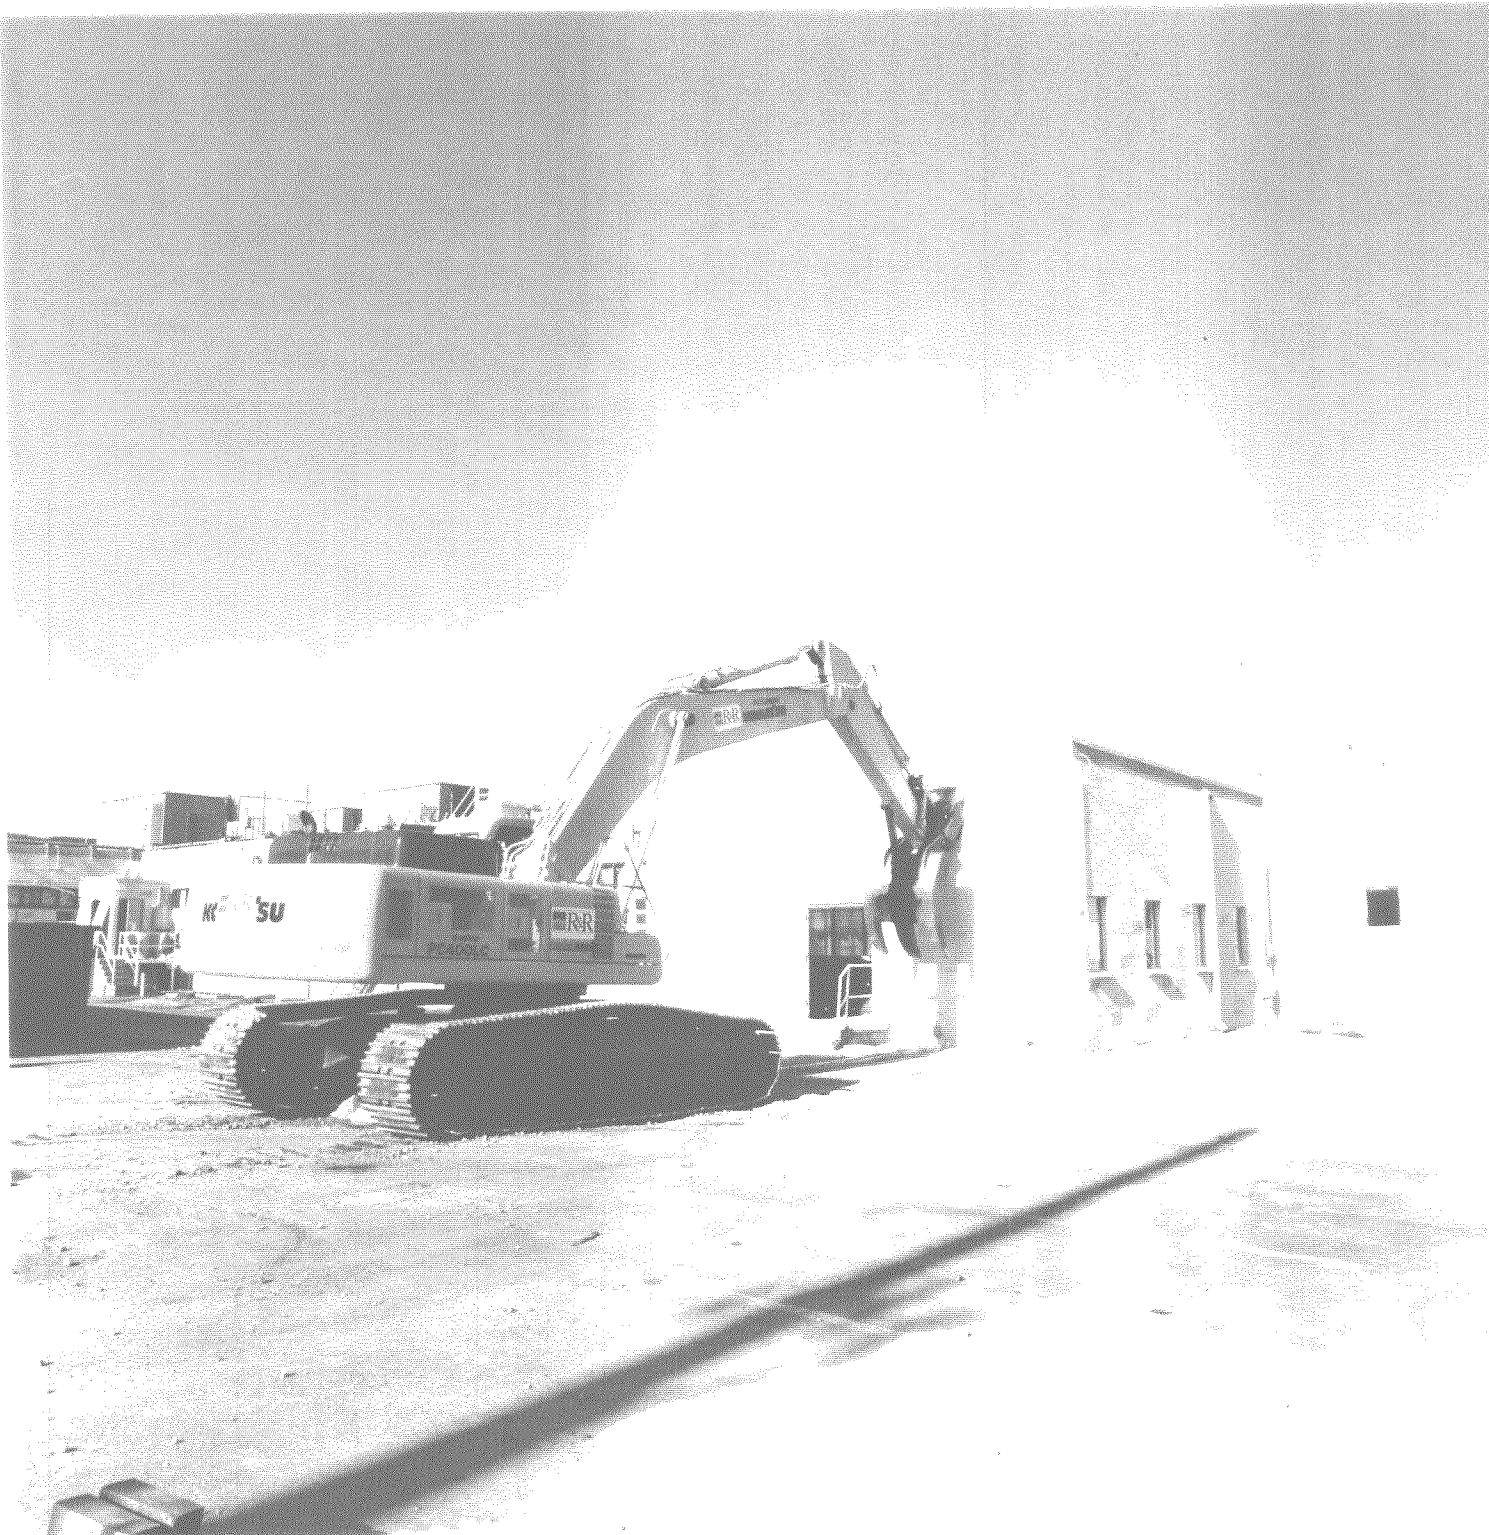
DESCRIPTION - ROCKY FLATS FIELD OFFICE
BLDG. - 123
CONTRACTOR - DENVER WEST REMEDIATION & CONSTRUCTION
#50581 - 09 - BUILDING 123 DEMOLITION, THE FIRST BITE
4/28/98
